Contract #: 04-0120F4Cty: SF/ALA Rte: 80 PM: 13.2/13.9File #: 69.28**WELDING INSPECTION REPORT****Resident Engineer:**Siegenthaler, Peter**Address:** 333 Burma Road**City:** Oakland, CA 94607**Report No:** WIR-017985**Date Inspected:** 07-Nov-2010**Project Name:** SAS Superstructure**OSM Arrival Time:** 700**Prime Contractor:** American Bridge/Fluor Enterprises, a JV**OSM Departure Time:** 1900**Contractor:** Zhenhua Port Machinery Company, Ltd (ZPMC), Changxing Island **Location:** Shanghai, China**CWI Name:** Li Yang**CWI Present:** Yes No**Inspected CWI report:** Yes No N/A**Rod Oven in Use:** Yes No N/A**Electrode to specification:** Yes No N/A**Weld Procedures Followed:** Yes No N/A**Qualified Welders:** Yes No N/A**Verified Joint Fit-up:** Yes No N/A**Approved Drawings:** Yes No N/A**Approved WPS:** Yes No N/A**Delayed / Cancelled:** Yes No N/A**Bridge No:** 34-0006**Component:** OBG Segment**Summary of Items Observed:**

## WELDING INSPECTION REPORT

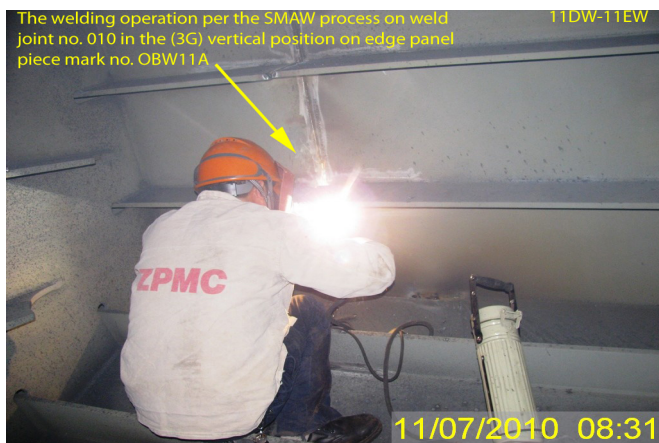
The QA inspector observed the welding operation per the SMAW process on weld joint no. 010 in the (3G) vertical position on edge panel piece mark no. OBW11A. The location was the transverse splice weld joining segment 11DW and 11EW. The welder ID was 040611. The ZPMC CWI was identified as Li Yang. The welding variables recorded by QC appeared to comply with the WPS-B-P-2213-B-U2-FCM-1.

For additional information please reference the pictures below:
